RESTORATION – “MUSEUM KIRCHE ZUM HEILIGEN KREUZ (KREUZKIRCHE) ZITTAU”

Use of the DESOI Anchor Stocking System

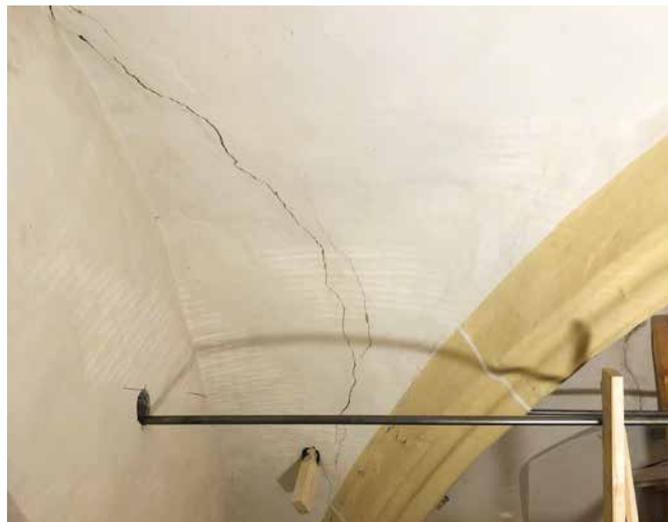
Crack formation

At the beginning of 2019, employees of Zittau's municipal museums informed the municipal building department that existing cracks in the church's sacristy were widening. A static report was then commissioned without delay. As part of this report, significant static and structural weaknesses were found in the supporting structure of the canopy roof, which covers the sacristy, as a result of which high horizontal shear forces were able to act on the sacristy's longitudinal wall.

These horizontal forces contributed significantly to the sacristy's structure being pushed away from the nave, which was leading to cracks of alarming proportions opening up in both the gable wall and in the sacristy's cross vault.

In addition, it was found that a technical room installed twenty years earlier above the sacristy's cross vault was resting directly on the vault. The additional horizontally directed shearing forces caused by this load were a second significant factor leading to the widening of the cracks in the vault and the gable wall.

The renovation measures' objective was to minimise or better distribute the loads acting on the building, to neutralise the shearing forces acting on the vault and to stop the sacristy from moving any further from the main nave. The building is a monument of the utmost importance. All work steps had to be carried out with care and with a view to prevent damage to the building and all objects located therein.

Among other things, the use of the DESOI Anchor Stocking System ensured the safeguarding of the historic masonry structure and stabilised the masonry fabric.

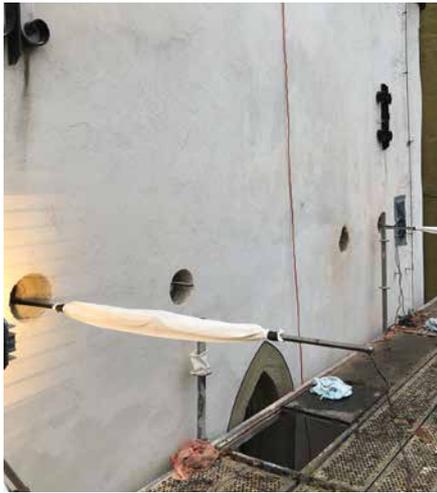
To protect the valuable murals, the stocking anchors could not be installed from within the church's interior.

Once the construction site had been fully established, the executing specialist company Ansorge carried out all the necessary drilling work using the dry drilling method. Particularly unusual were the two horizontal boreholes along the outer masonry wall, which the company Ansorge from Zittau, known as “Bohrwurm”, created to a depth of 6.50 metres. The boreholes (diameter of 80 mm) were then cleaned by brushing and blowing.

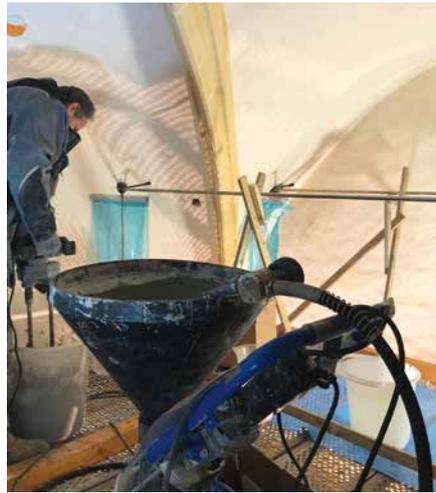
Mixing the DESOI AnchorNox® dry mortar before the anchor rods were injected

The DESOI AnchorNox® dry mortar was mixed using a manual DESOI Power-Mix HZM-1 mixer (forced mixing). Subsequently, for quality control purposes, a consistency test was carried out with a spreading plate.

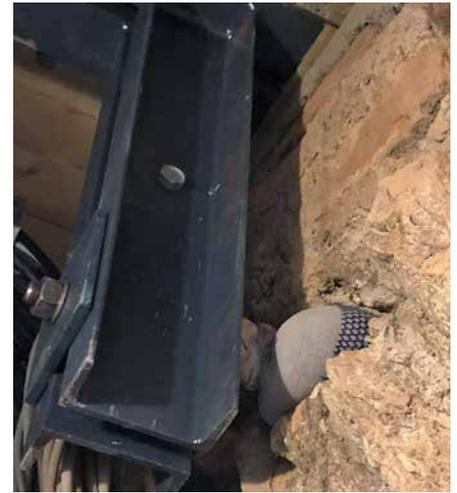
Fully compressed anchor stocking system

Longer anchor rods were adapted on site to the local conditions. Concrete ribbed steel reinforcements and threaded anchors were installed with diameters of 20 – 22 mm. Depending on the anchors' length, a number of spacers were installed. The anchor stocking was sheathed in a woven protective mesh in the area around the spacers to prevent tears while it was being pushed into the borehole.

The anchor stocking system was then completely backfilled with DESOI AnchorNox® dry mortar using an internal material feed line. The tested anchor mortar from DESOI has good flowability, is sedimentation-free with a stable consistency and machine compatible. It achieves high early and final strengths (compressive strength > 40 N / mm² and flexural tensile strength > 7 N / mm² in each case after 28 days) and meets the conditions required for building material class A1 (non-combustible), while also being resistant to temperature changes (frost-thaw cycles) and sulphates.

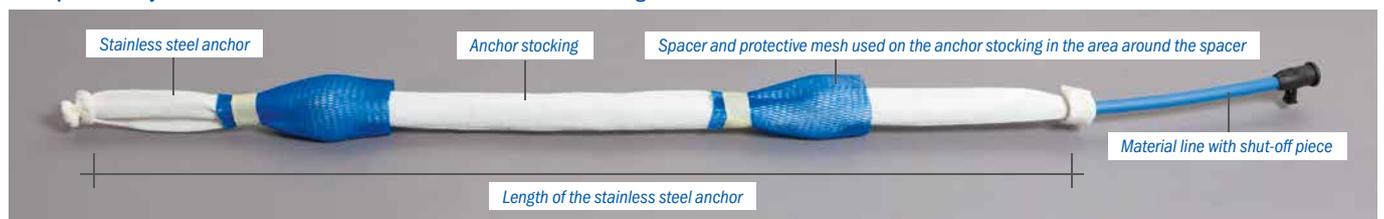
Example: Factory-assembled stainless steel anchor with anchor stocking

Another special feature: the stainless steel tie rods used to protect the vault comprised of several parts. Inside the chancel's brickwork, concrete ribbed steel, equipped with an anchor stocking, was anchored on both sides, compressed and then connected to a smooth, stainless steel tension rod, which was stretched across the entire chancel.

For this purpose, it was necessary create anchors equipped with a number of different threads of varying lengths, in advance, at the DESOI plant. This special service, too, is made possible by DESOI's in-house production.
